# Seawall Phase II Investigation

Rogue Brewery Seawall  
Newport, Oregon

Prepared for:  
Port of Newport  
600 SE Bay Boulevard  
Newport, Oregon 97365

October 18, 2021  
PBS Project 74183.000

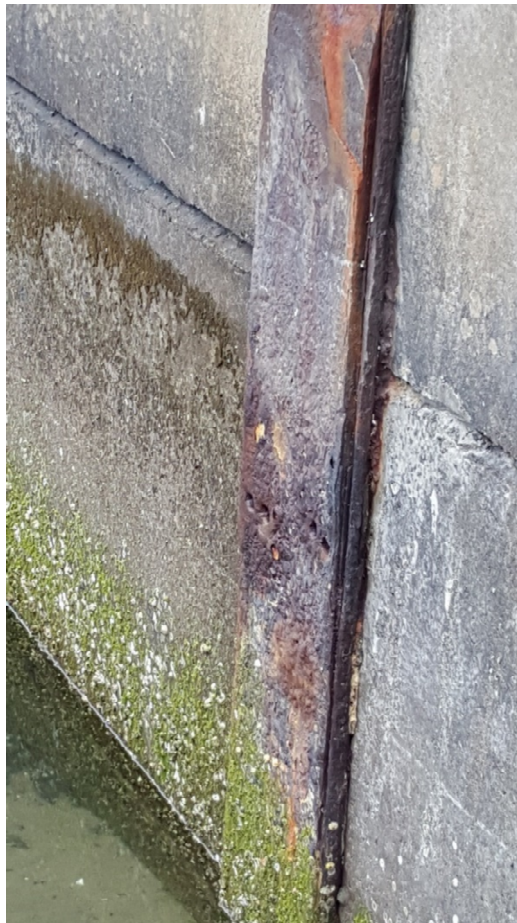
**Figure 1. Steel Pile at Splash Zone**

The steel piles of the seawall were measured by ultrasonic testing (UT). The level of corrosion was determined by comparing the original dimensions of the piles to the measured dimensions. The steel piles of the seawall were measured in 18 locations.

The thicknesses of the pile flanges measured in the previous Berger/ABAM report are used along with the expansion factor of 4 to determine the effective flange remaining. An expansion factor of 3 is also used to determine a worst case. The Effective Flange Remaining is determined by subtracting the Calculated Loss from the Original Base Thickness. The Corroded Section Thickness (Measured Thickness plus the Generalized Loss) is the Original Base Thickness plus the Corrosion Thickness minus the Calculated Loss. The Corrosion Thickness is the Expansion Factor multiplied by the Calculated Loss. The Calculated Loss is determined from the Corrosion Thickness and the Expansion Factor. The Moment Capacity is determined by calculating the moment of inertia of the W18x97 with one flange thickness as the Effective Flange Remaining. The percentage ratio is determined by comparing the moment capacity using the published moment of inertia value of the W18x97 to the reduced value.

**Repair Option A** - The loss of effective flange thickness due to corrosion in the steel piles can be made up by welding steel plates to the outside of the flanges. This will increase the bending capacity of the steel piles. The welds between the new steel and the existing steel piles will be at locations above and below the waterline. Underwater welding will be part of the installation of this repair option.

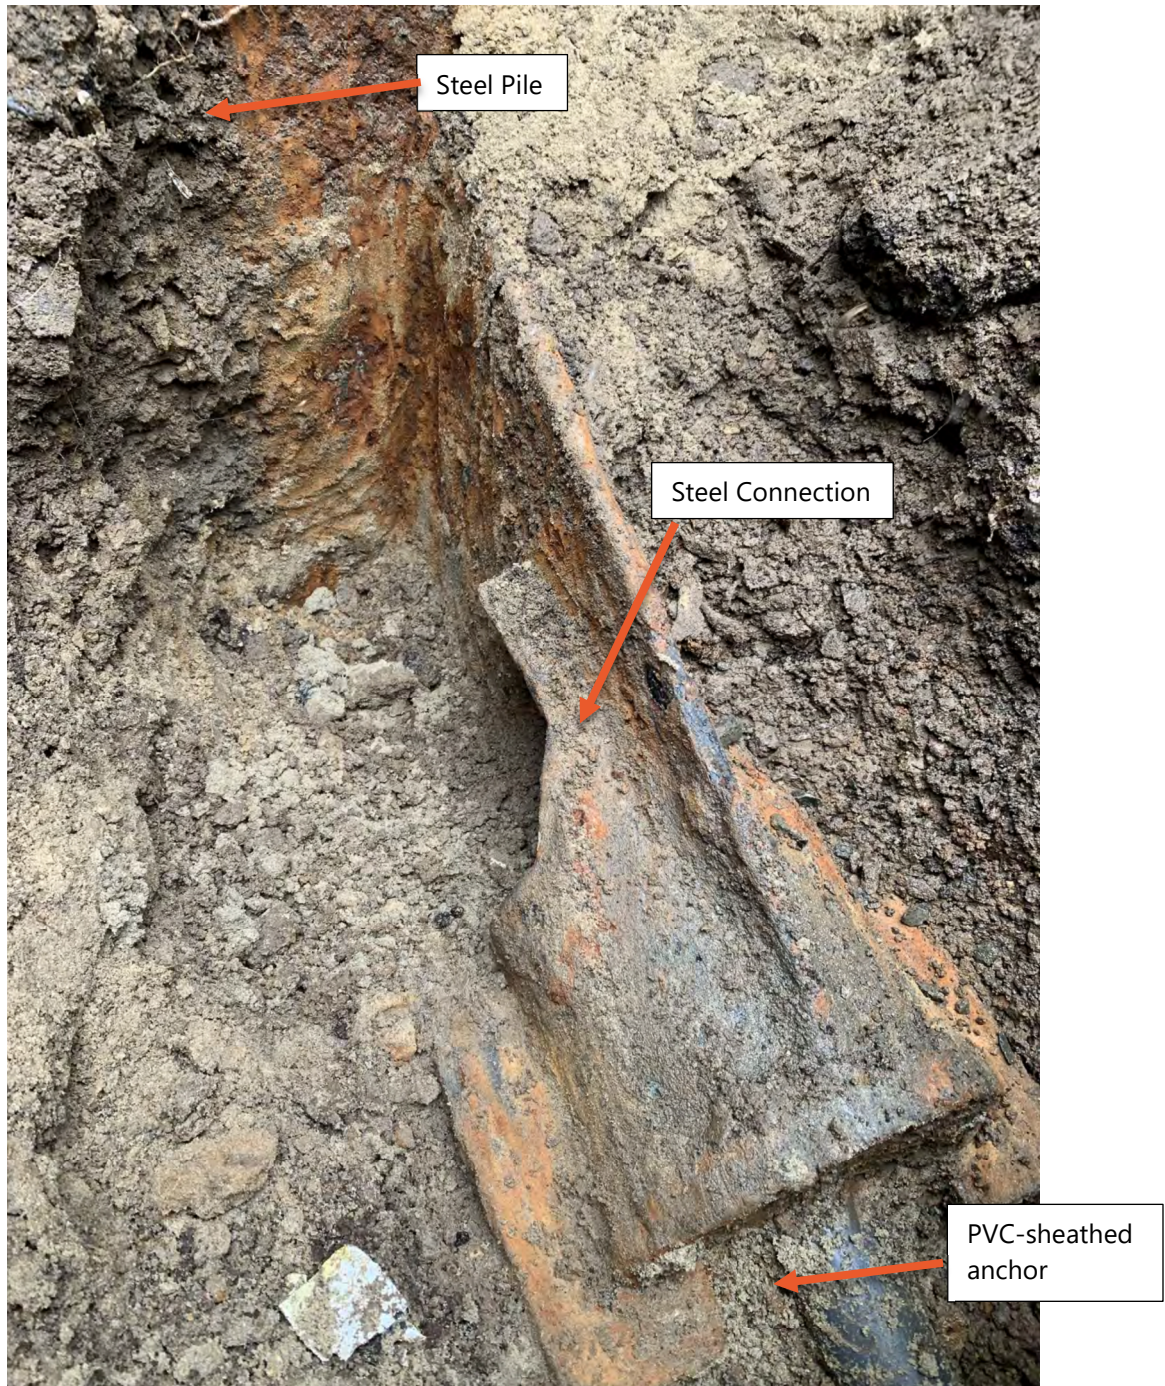
**Figure 2. Seawall Tie-back Anchor Connection**

One tie-back anchor connecting the vertical steel pile and concrete deadman block was exposed for observation. On May 24, 2021, the tie-back anchor connected to pile number 50 was investigated to determine the level of corrosion at both the seawall anchor point and at the deadman anchor point. This tie-back anchor is located on the west end of the seawall. Refer to as-built drawing number 7-E-240 in Appendix E. The anchor at the seawall showed signs of corrosion (See Figure 2). However, the steel connection from the anchor to the pile looked to be intact. No significant loss of steel was observed. The anchor to deadman connection was observed on both sides of the deadman. The tendon is encased in a protective sleeve and the end of the anchor had a protective covering (See Figures 3 & 4). The corrosion level of the tendon could not be determined through observation. The plate that acts as a washer between the anchor end and the deadman showed signs of corrosion but did not have a significant loss of steel. The corrosion protection measures appeared to be intact. Note that we were only able to observe these connections from a distance of approximately 6 feet due to limited access due to the temporary excavation techniques. Only one tie-back out of 54 was observed. Defects in other elements that we were not able to observe may be present.

Based on this observation, it is our opinion that the tieback anchors can be considered to be capable of functioning as originally intended. As discussed elsewhere in this report, the original design did not explicitly consider seismic forces and is unlikely to be adequate to resist a modern design earthquake event.

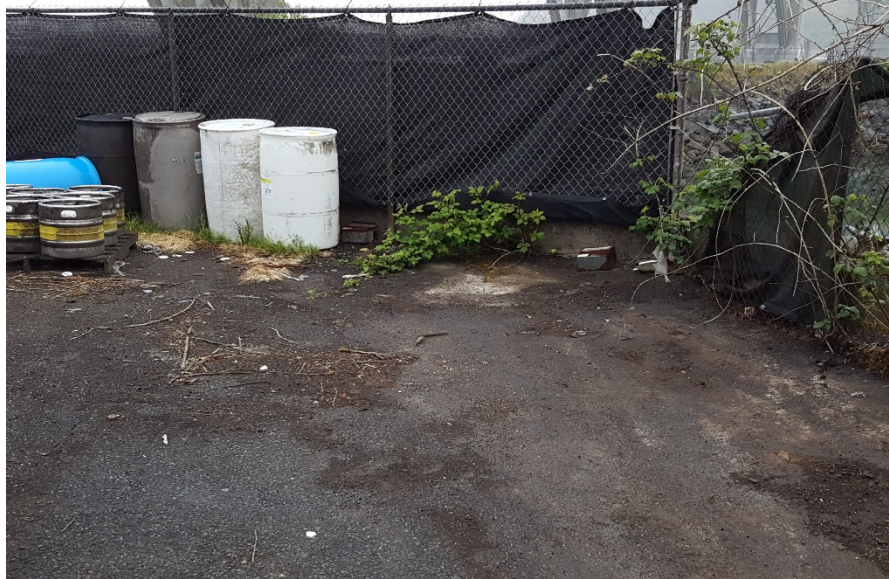
**Figure 5. West End Soil Stabilization Access**

The west end of the seawall, outside the building, can be easily accessed for the installation of soil stabilization process (See Figure 5). This is the same location that was used for the deadman anchor observations, and a large vacuum excavator truck was able to operate in this area. The interior of the building next to the seawall has limited access points, however a few access points were installed in the building as part of prior investigations, and they would presumably be relatively accessible for the injection operation (See Figure 6). The east end of the seawall was not observed during the site visit due to kegs and other material obstructing access. The kegs and other materials would need to be relocated for the soil stabilization process. It is our opinion that the eastern area outside the building footprint would present no difficulties for the soil stabilization process.

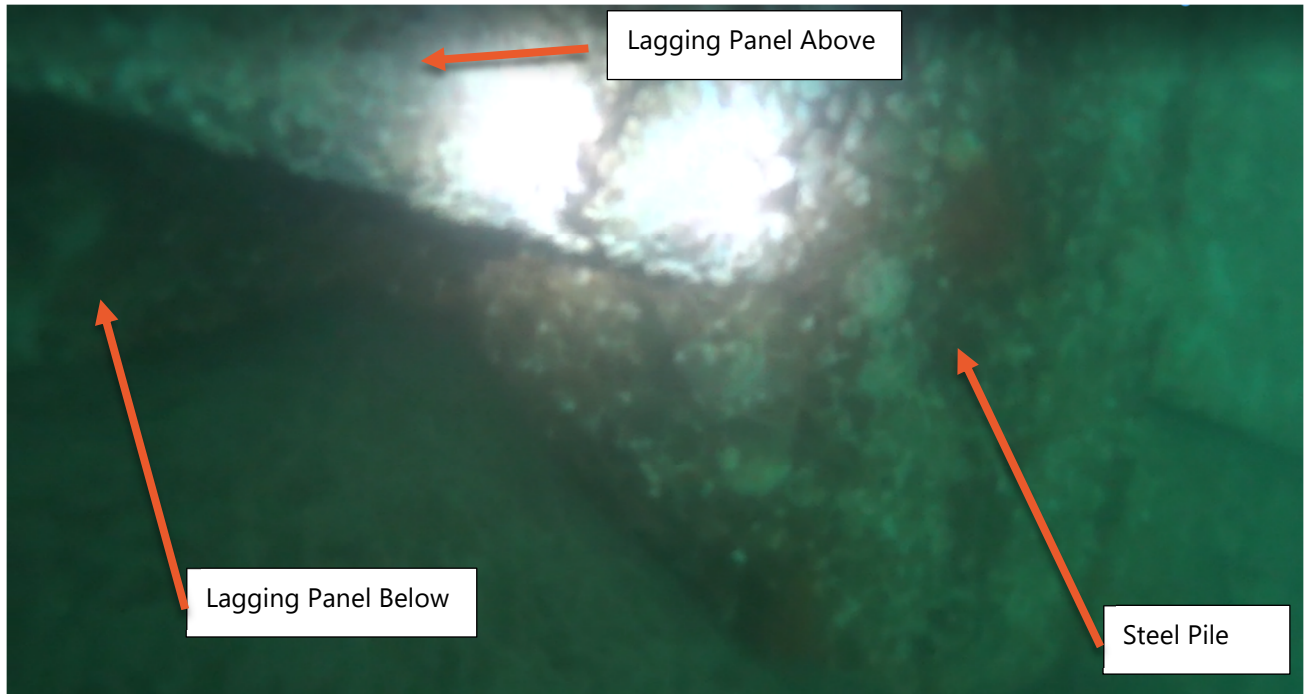
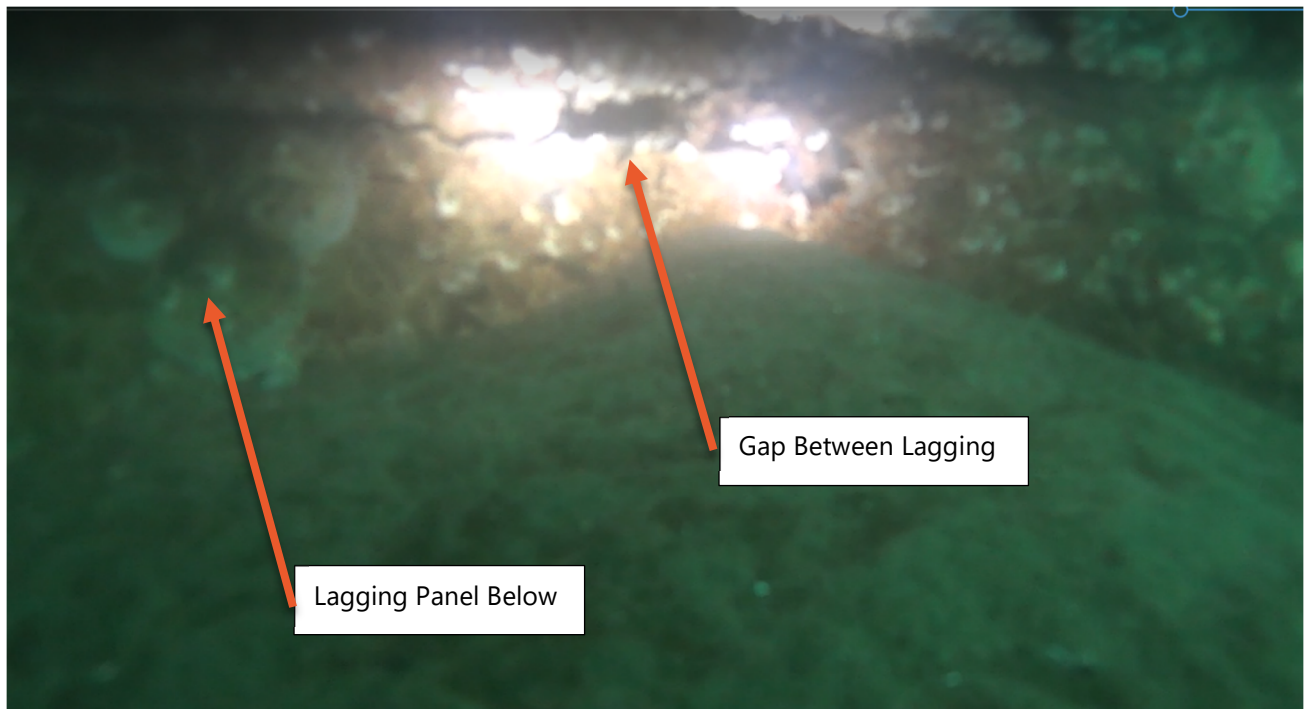
PBS reviewed video of an underwater inspection conducted circa 2018. We observed misaligned concrete lagging panels that appear to have the potential for allowing backfill to pump through the gaps in the panels. Two screen captures from the video at the same wall location are given in Figures 7 & 8.

**Figure 7. Underwater Concrete Lagging**

**Figure 8. Underwater Concrete Lagging**

The corrosion protection will be provided by installing a coating system. The soil stability will be improved by polymer injection. There is historical video evidence of misaligned concrete lagging panels underwater and the assumption is that backfill material is pumping through the gaps in the panels. The polymer injection is likely to solve the problem of the gaps in the lagging panels, however this specific case should be considered during final design of the polymer injection system. If the polymer injection cannot self-seal gaps that large, containment plates may be required. The cost estimates for polymer injection include an allowance for minor underwater repair at these locations.

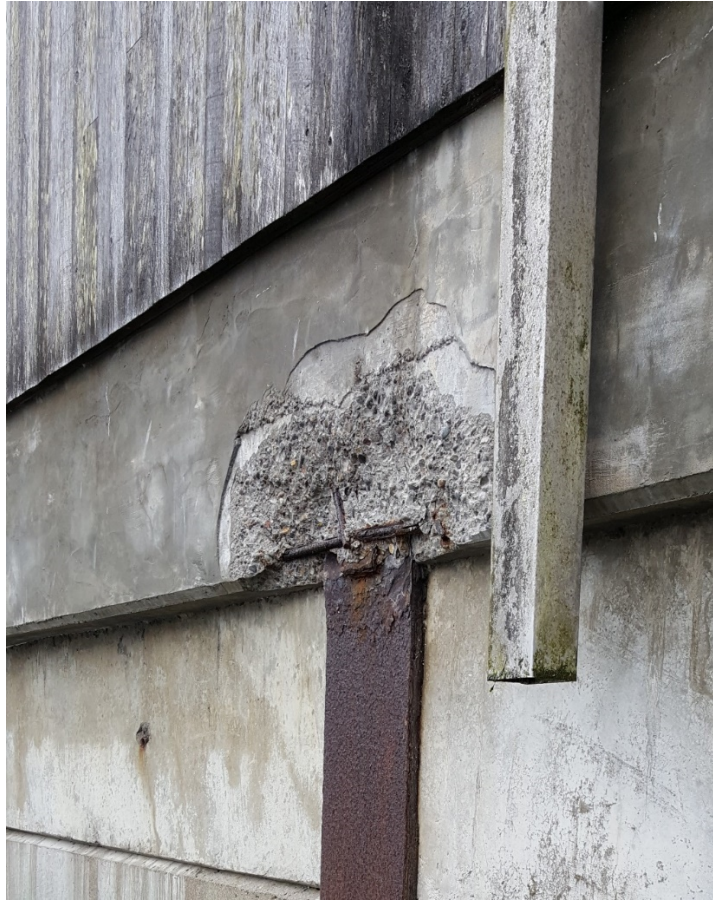
**Figure 9. Concrete Spalling at Pile Cap**

In addition to the two major repair schemes, some general repair should be included in the project along with the pile coating and soil stabilization, regardless of which option is chosen. This includes repair of the concrete spalling of the pile cap and repair of localized lagging damage above and below the water.

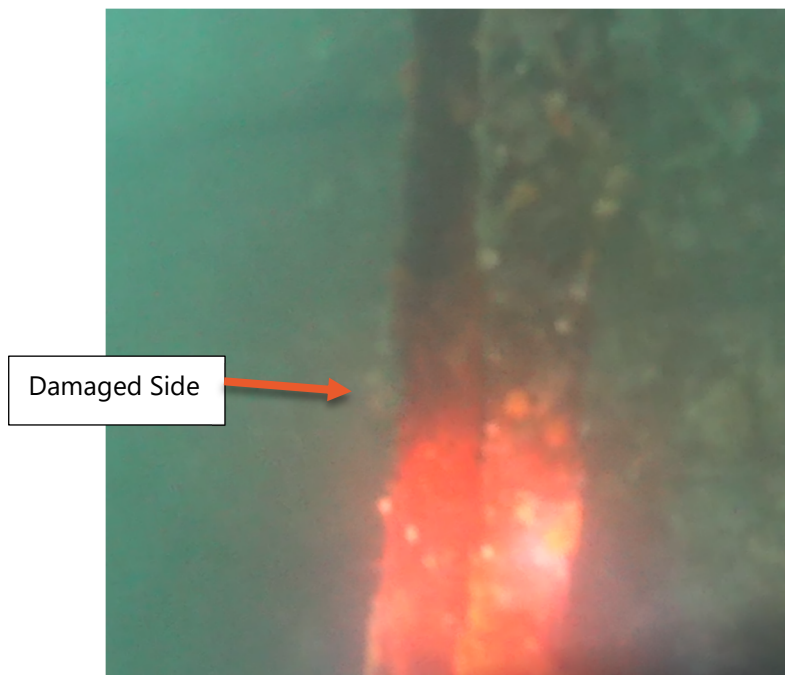
**Figure 10. Damaged Pipe Pile**

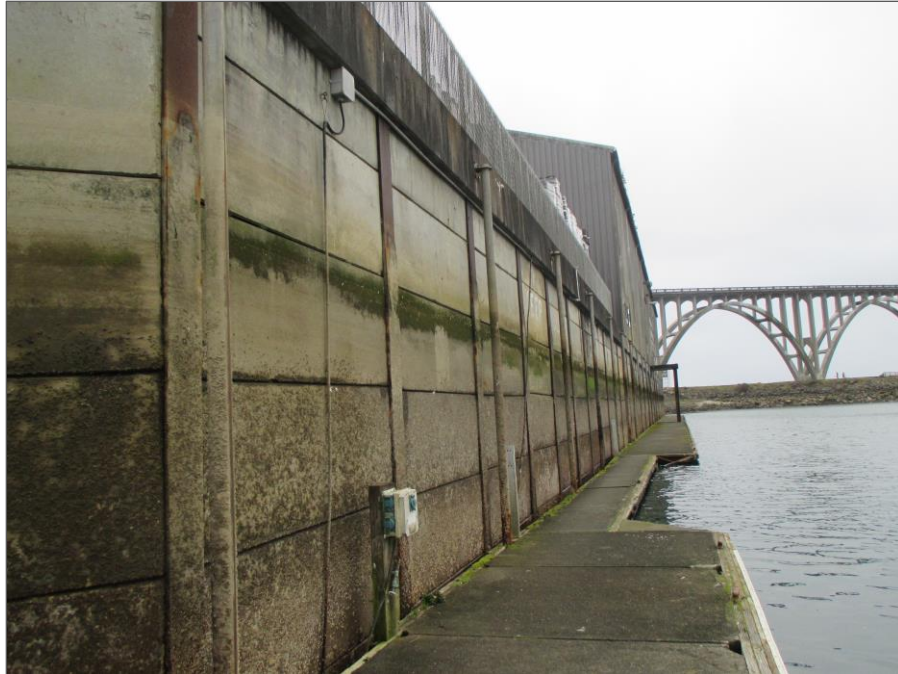
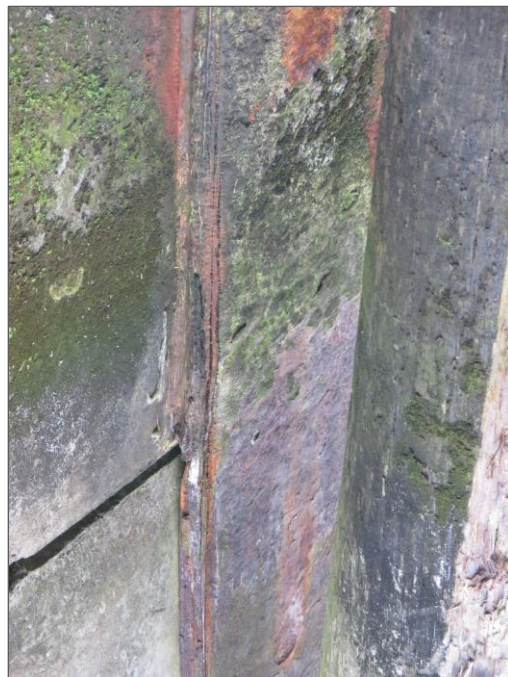
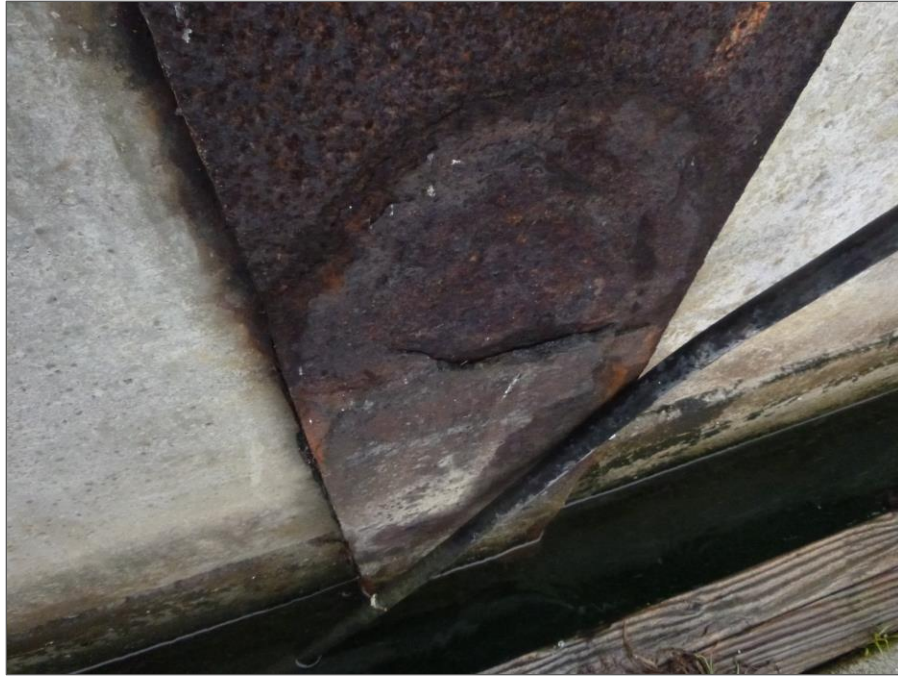
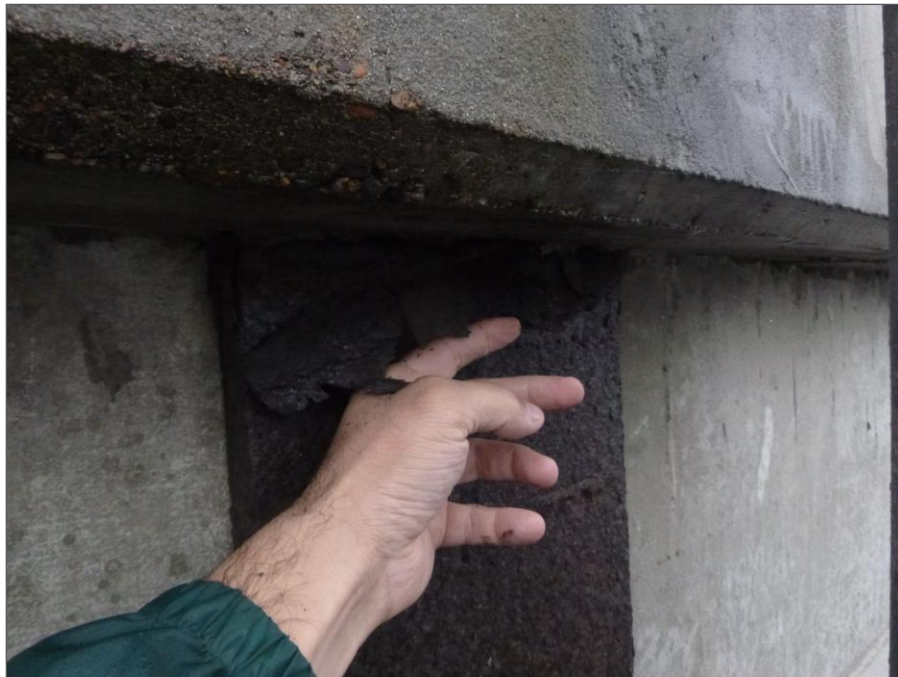
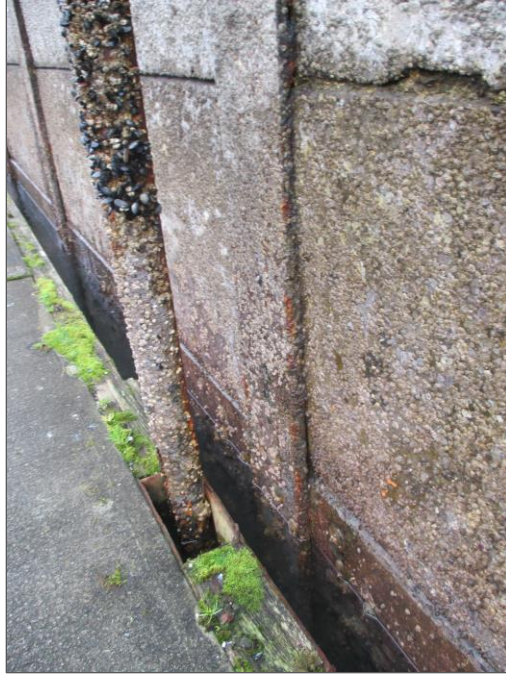
Figure 1 (a through e) shows the typical damage to the soldier piles. There is corrosion damage visible as laminated rust in two zones (a) the tide splash zone (elevation -3 feet to elevation +10 feet on average) and (b) below the cap beam on the all soldier piles. Considerable expansion was observed on the seaside pile flange showing a thickness increasing to approximately 1-1/4 to 2 inches (originally 0.87 inch for W18x97).

**1(a). Corrosion on soldier piles  
(27 February 2018)**

**1(b). Typical chloride-induced corrosion damage in splash zone  
(27 February 2018)**

**1(c). Typical chloride-induced corrosion damage in splash zone  
(8 October 2018)**

**1(d). Typical chloride induced corrosion damage under the pile cap  
(8 October 2018)**

**1(e). Formation of calcium carbonate shows the possibility of carbon-induced corrosion  
(27 February 2018)**

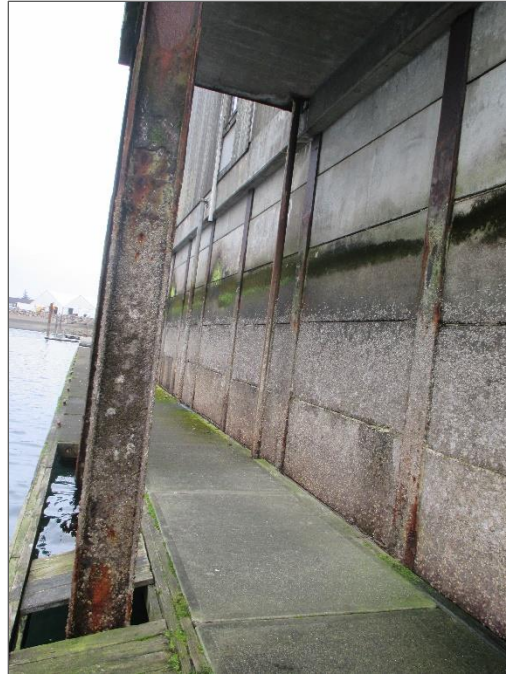
The concrete laggings are in generally good condition in terms of concrete surface quality (cracks, spalling, etc.) and vertical alignments. Figure 2 shows a typical lagging condition.

**Figure 2. Concrete lagging existing conditions**  
 (There are surface effects from water; however, the overall visual inspection seemed acceptable at this point.)

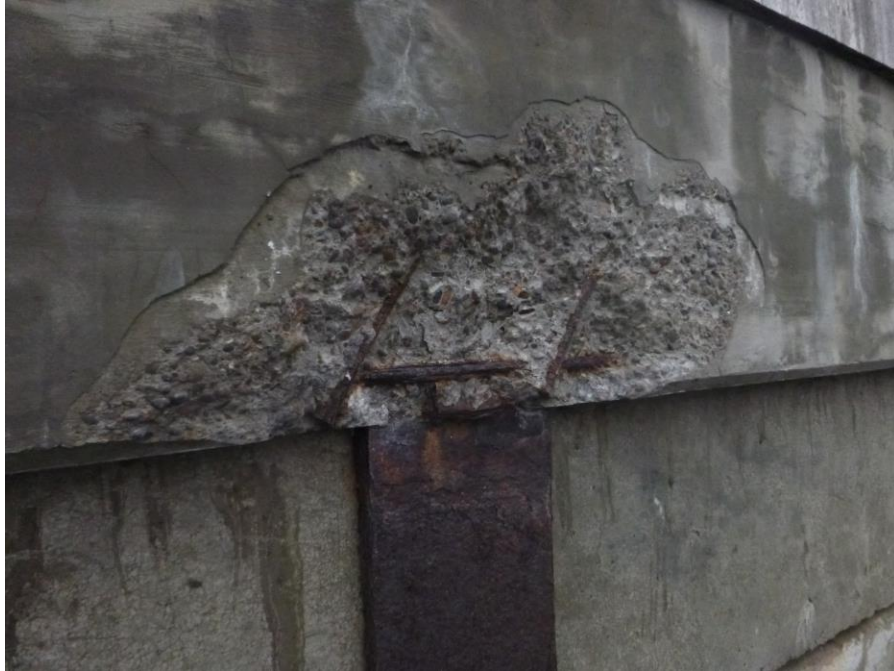
There is visible damage on the intersection of pile cap and solder piles in many locations. At some points, as shown in Figure 3(a), concrete spalling is evident. The spalling is most probably related to minor tension happening on pile cap face due to lateral pile deformations (i.e., minor axis bending on the pile cap). There are many other locations where small repairs have been performed over time for outer cracking on pile cap, shown in Figure 3(b).

**3(a). Concrete spalling on pile cap (Pile No. 42, see as-built drawings)**

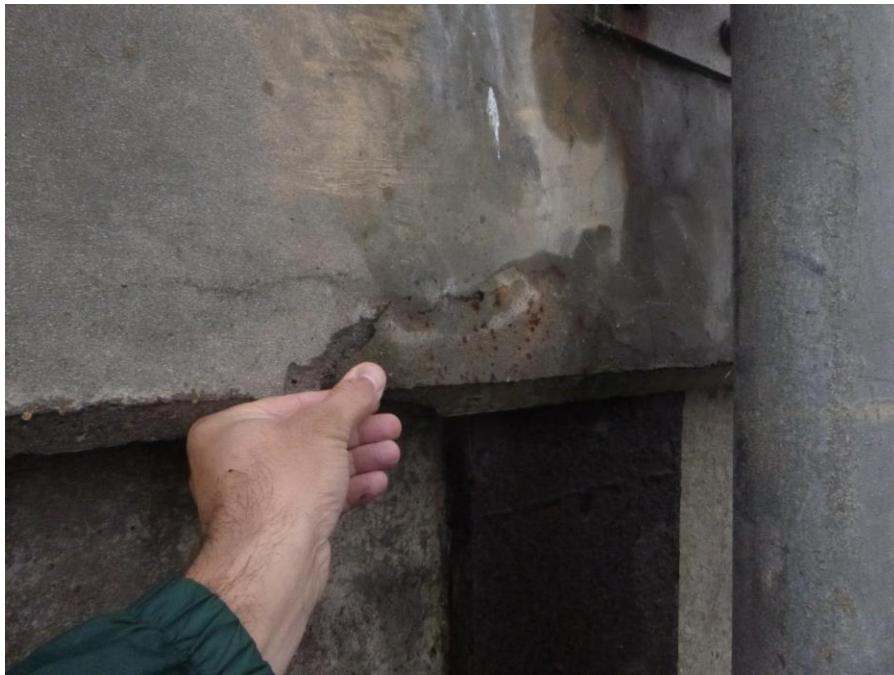
**3(b). Repairs for cracks on pile cap face**

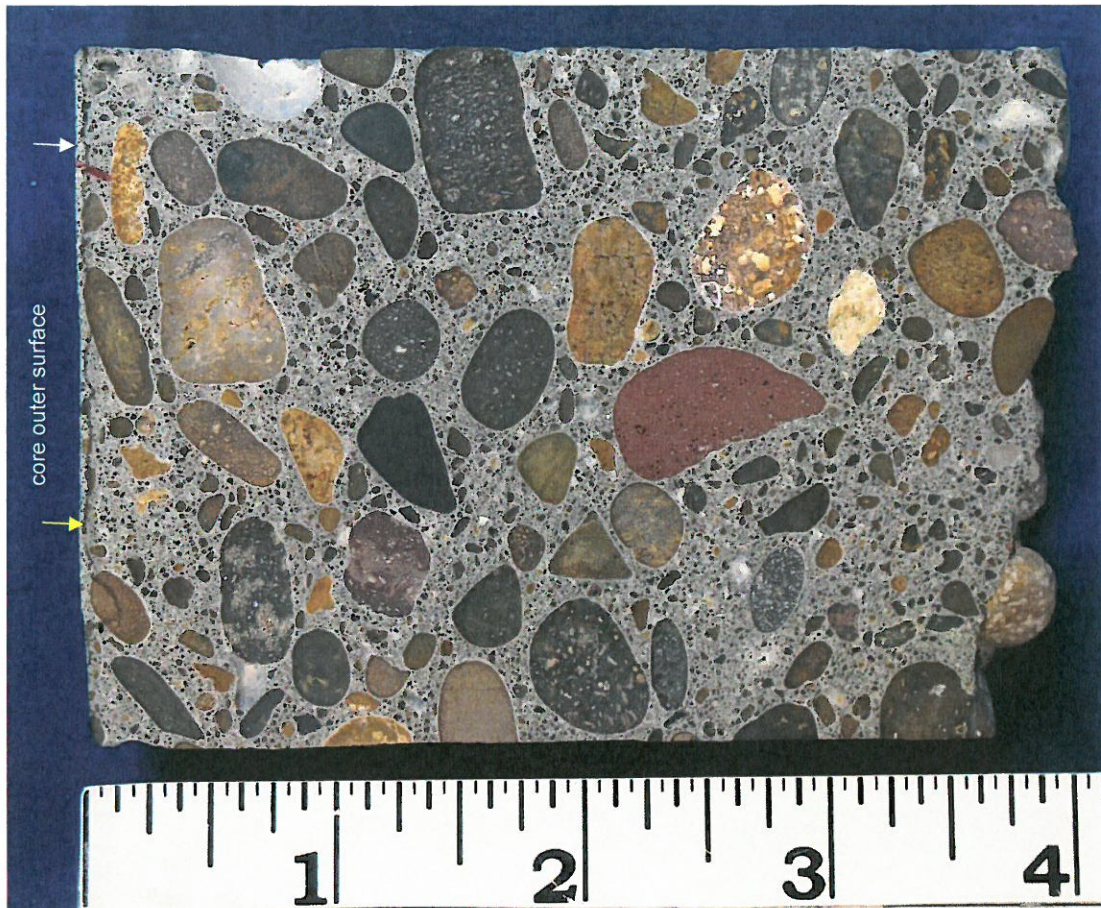
**Fig. 2** Lapped, cross-sectional concrete surface of Core S2101564.

No cracks are present. One short microcrack (outline in red), perpendicular to the core outer surface, is present at the core outer surface, extending to a depth of 4 mm (0.02 in.).
