# Seawall Phase II Investigation

Rogue Brewery Seawall  
Newport, Oregon

Prepared for:  
Port of Newport  
600 SE Bay Boulevard  
Newport, Oregon 97365

October 18, 2021  
PBS Project 74183.000

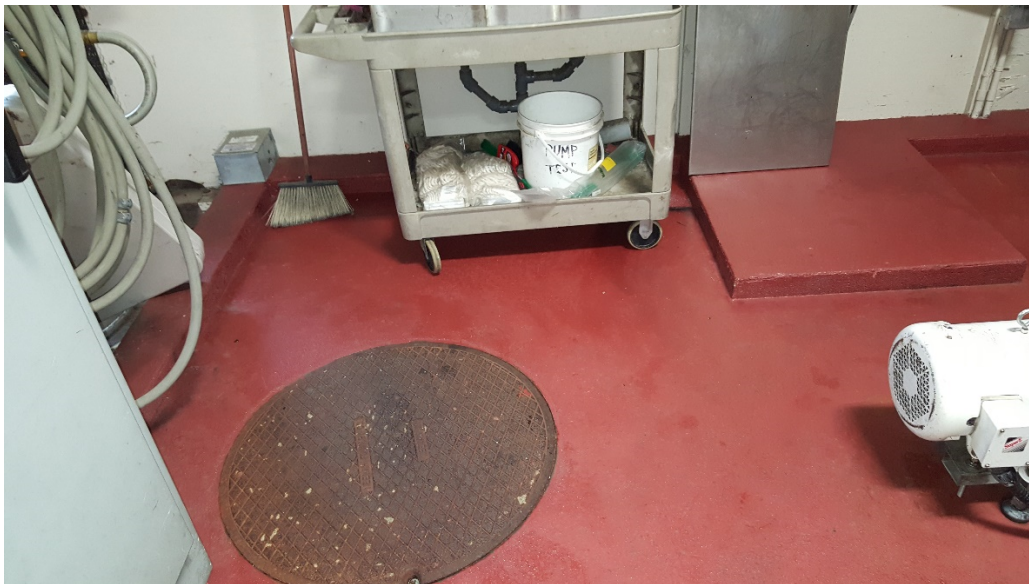
**Figure 6. Interior Soil Stabilization Access Location**

The west end of the seawall, outside the building, can be easily accessed for the installation of soil stabilization process (See Figure 5). This is the same location that was used for the deadman anchor observations, and a large vacuum excavator truck was able to operate in this area. The interior of the building next to the seawall has limited access points, however a few access points were installed in the building as part of prior investigations, and they would presumably be relatively accessible for the injection operation (See Figure 6). The east end of the seawall was not observed during the site visit due to kegs and other material obstructing access. The kegs and other materials would need to be relocated for the soil stabilization process. It is our opinion that the eastern area outside the building footprint would present no difficulties for the soil stabilization process.

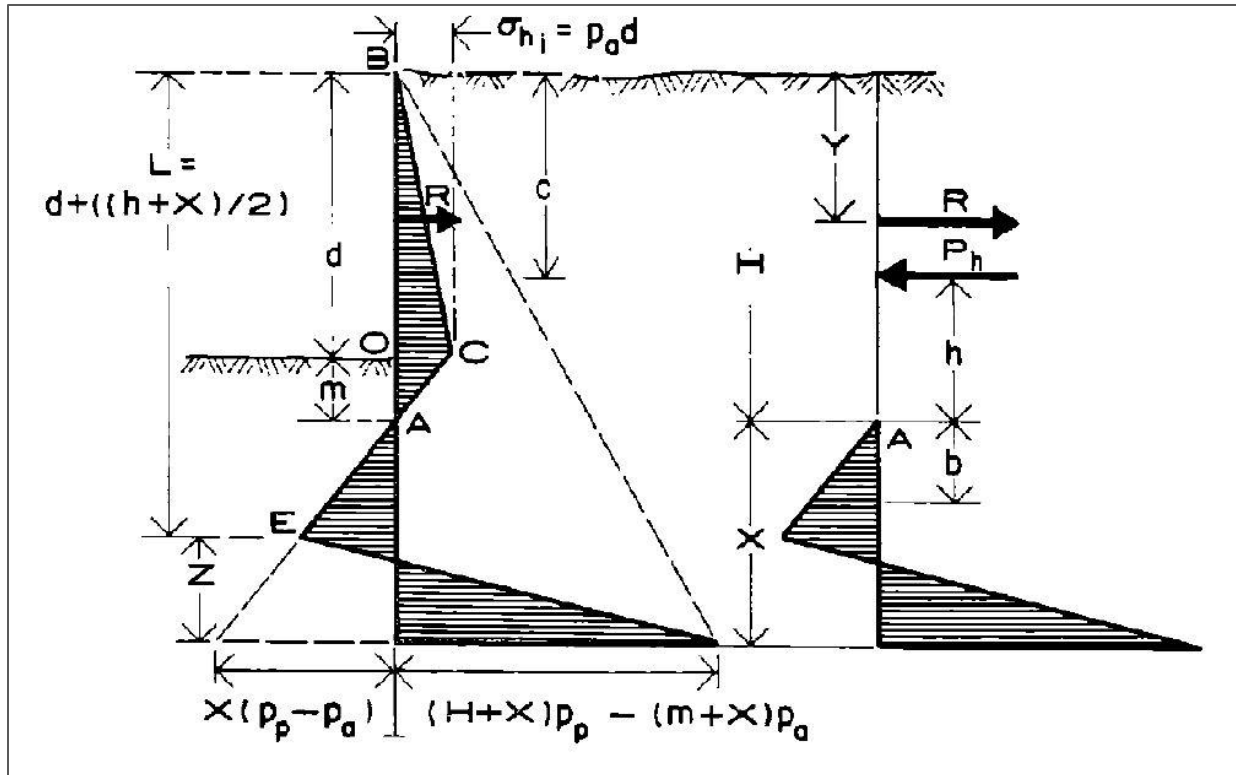
**Figure 4. Backfill loading on soldier piles**  
 (Reference: Retaining Wall Design Guide, FHWA-FLP 94006)

1. The geotechnical parameters were provided by GRI based on typical average soil types in South Beach Marina, Newport, Oregon (including friction angle as 35 degrees and soil density as 110 pounds per cubic foot).
2. Full drainage was assumed resulting in no hydrostatic pressure behind the wall.
3. The soil was considered saturated below the water level at elevation 0 feet (MLLW) as shown on the as-built drawings.

Figure 4 shows the loading assumption on the soldier pile with tie-back wall. According to as-built drawings, the piles were not driven to bedrock. The tie-back and W-sections will be rechecked based on AISC-ASD for the tallest piles (Pile Nos. 7 through 52).

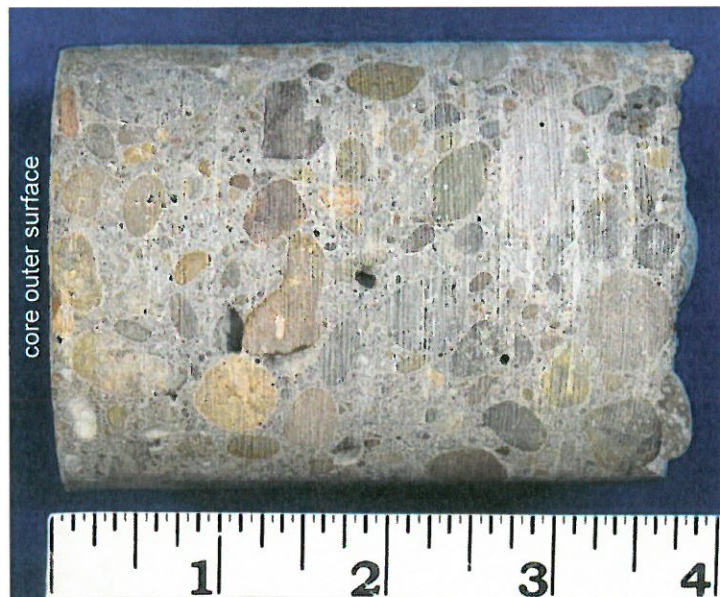
1b. Side view of core.

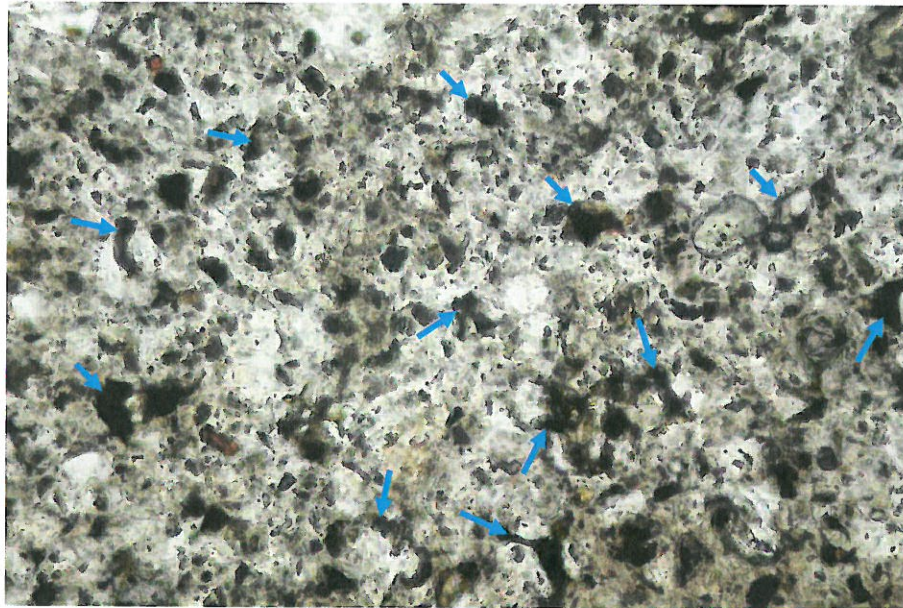
- Paste. Paste in the outer 1 mm of the core is light gray and moderately soft, following by a thin (less than 0.1 mm (0.004 in.) thick) dark gray, very hard line; this line appears to be a water infiltration line. Paste in the remainder of the core is medium-dark gray and hard. The paste-to-aggregate bond is weak; this is typical of concrete with rounded natural gravel. The depth of paste carbonation is 1.5 mm from the core outer surface. Ettringite is present, lightly lining many air voids. The residual amount of portland cement grains is estimated at 15 to 18%, by volume of paste. No supplementary cementitious materials are observed. The water-to-cement ratio (w/c) in the concrete is estimated at 0.34 to 0.40; this estimate is based upon the interpretation of the petrographically observed paste properties (Fig. 3)

3a. Plane-polarized light. Blue arrows designate residual portland cement grains, estimated at 15 to 18%, by volume of paste.

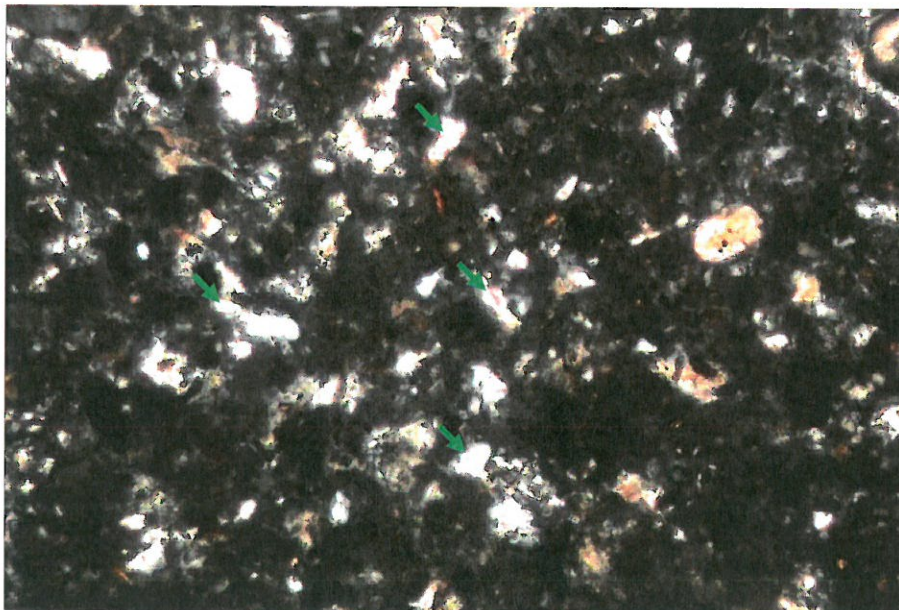
3b. Cross-polarized light. Calcium hydroxide (green arrows) is coarse and patchy.

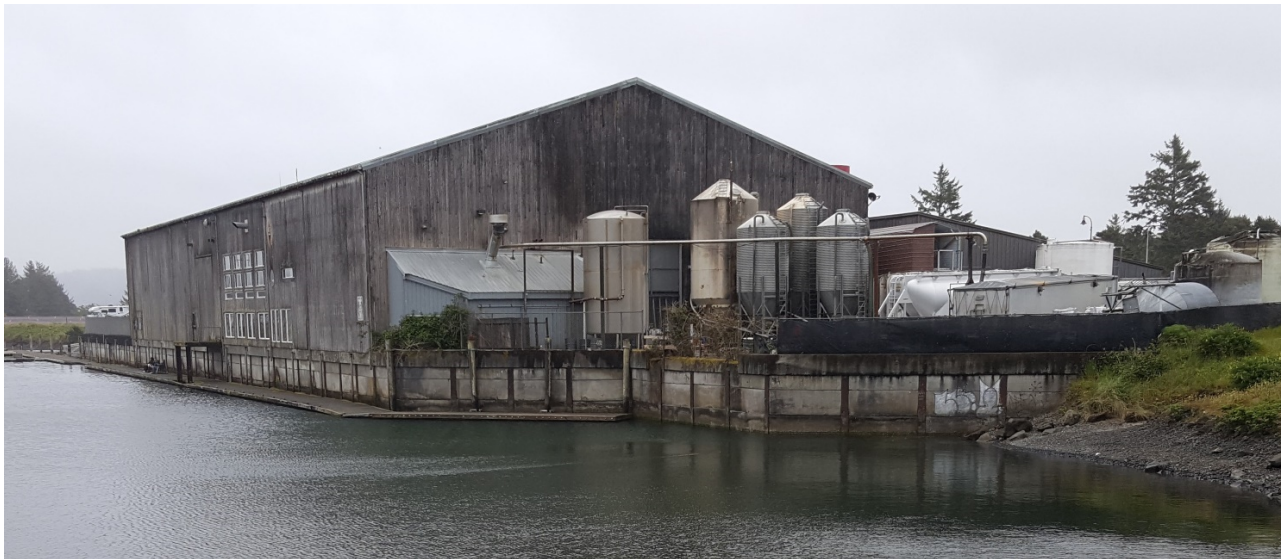
**Figure 3-1 Rogue Brewery Seawall**

The Rogue Brewery Seawall is approximately 540 feet long and supports the Rogue World Headquarters building. The seawall is a soldier pile wall with steel piles and concrete lagging. The seawall consists of 55 steel piles. The steel piles are approximately 60 feet in length with approximately 16 feet above the mean lower low water level (MLLW). The pile size is W18x97. The pile spacing is 10 feet. The concrete lagging consists of 9-inch-thick precast panels. Tieback rods are installed 6 feet below grade and connect the piles to precast concrete deadmen. The deadmen are 40-60 feet away from the face of the seawall, depending on location. The tops of the soldier piles are encased by a concrete grade beam that runs the length of the wall.

A floating dock is located along most of the face of the seawall. The dock is supported by pipe and timber piles located between the dock and the seawall. The tops of the piles are connected to the concrete grade beam.
